**Flood Control Project Maintenance
Levee Inspections**

Maintenance Issue Types Only, Levee Inspection Report By Mile - Fall 2016

Sutter Maintenance Yard Nelson Bend

Waterway	Bank	Unit Miles	Inspection Start/End	Inspector
Unit No. 01 Feather River West Levee - Nelson Bend		0.50	09/28/2016 09/28/2016	Sterling York

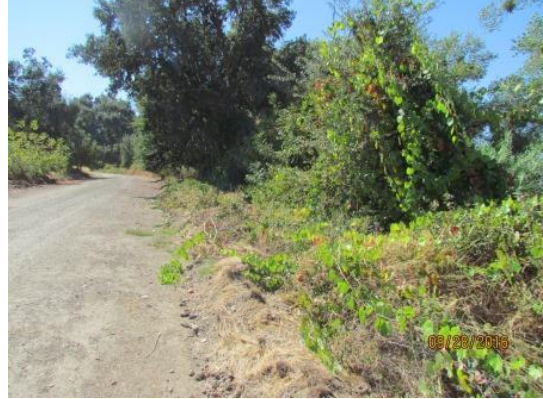
Photo 1 of 1 : FA_2016_ST0006_471_2_20160928_00008.jpg

LM Start	0.02	Rating **	U	Issue No.	2
LM End	0.46	Issue Type +	Ma	Location *	LS
Category	Earthen Levee			GPS Latitude/Longitude	
				Start	End
Item	Vegetation			38.886883 °	38.880833 °
				-121.614797 °	-121.614387 °
DWR ID	DWR_ST0006_01_f _ 2015_2				
Comment Code					
V2 : Remove the wild growth other than native grasses from the levee slopes.					
Inspector Comment					
Remove the vegetation, wild growth, and trim up the trees 5 feet for visibility.

View of the vegetation, wild growth, trees, and elderberries along the landside slope looking downstream. Fall 2016.

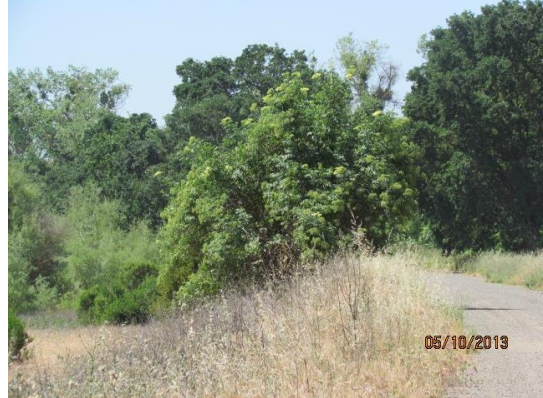
Photo 1 of 1 : FA_2016_ST0006_471_4_20160906_00002.jpg

LM Start	0.06	Rating **	M	Issue No.	4
LM End	0.06	Issue Type +	Ma	Location *	WS
Category	Earthen Levee			GPS Latitude/Longitude	
				Start	End
Item	Vegetation			38.886277 °	38.886277 °
				-121.615129 °	-121.615129 °
DWR ID	DWR_ST0006_01_s _ 2012_4				
Comment Code					
V4 : Elderberries are blocking visibility and flood fight capability.					
Inspector Comment					
Elderberries are partially blocking visibility.

View of the elderberries that are blocking visibility.
